# Land Suitability Analysis

Halifax Shopping Centre Annex (PID Nos. 41030636, 00017665, 41030644, 00017657, and 41030651),  
Halifax, Nova Scotia

OPB Realty Inc.  
c/o Cushman & Wakefield Asset Services ULC  
Report

March 7, 2023  
2207401.000

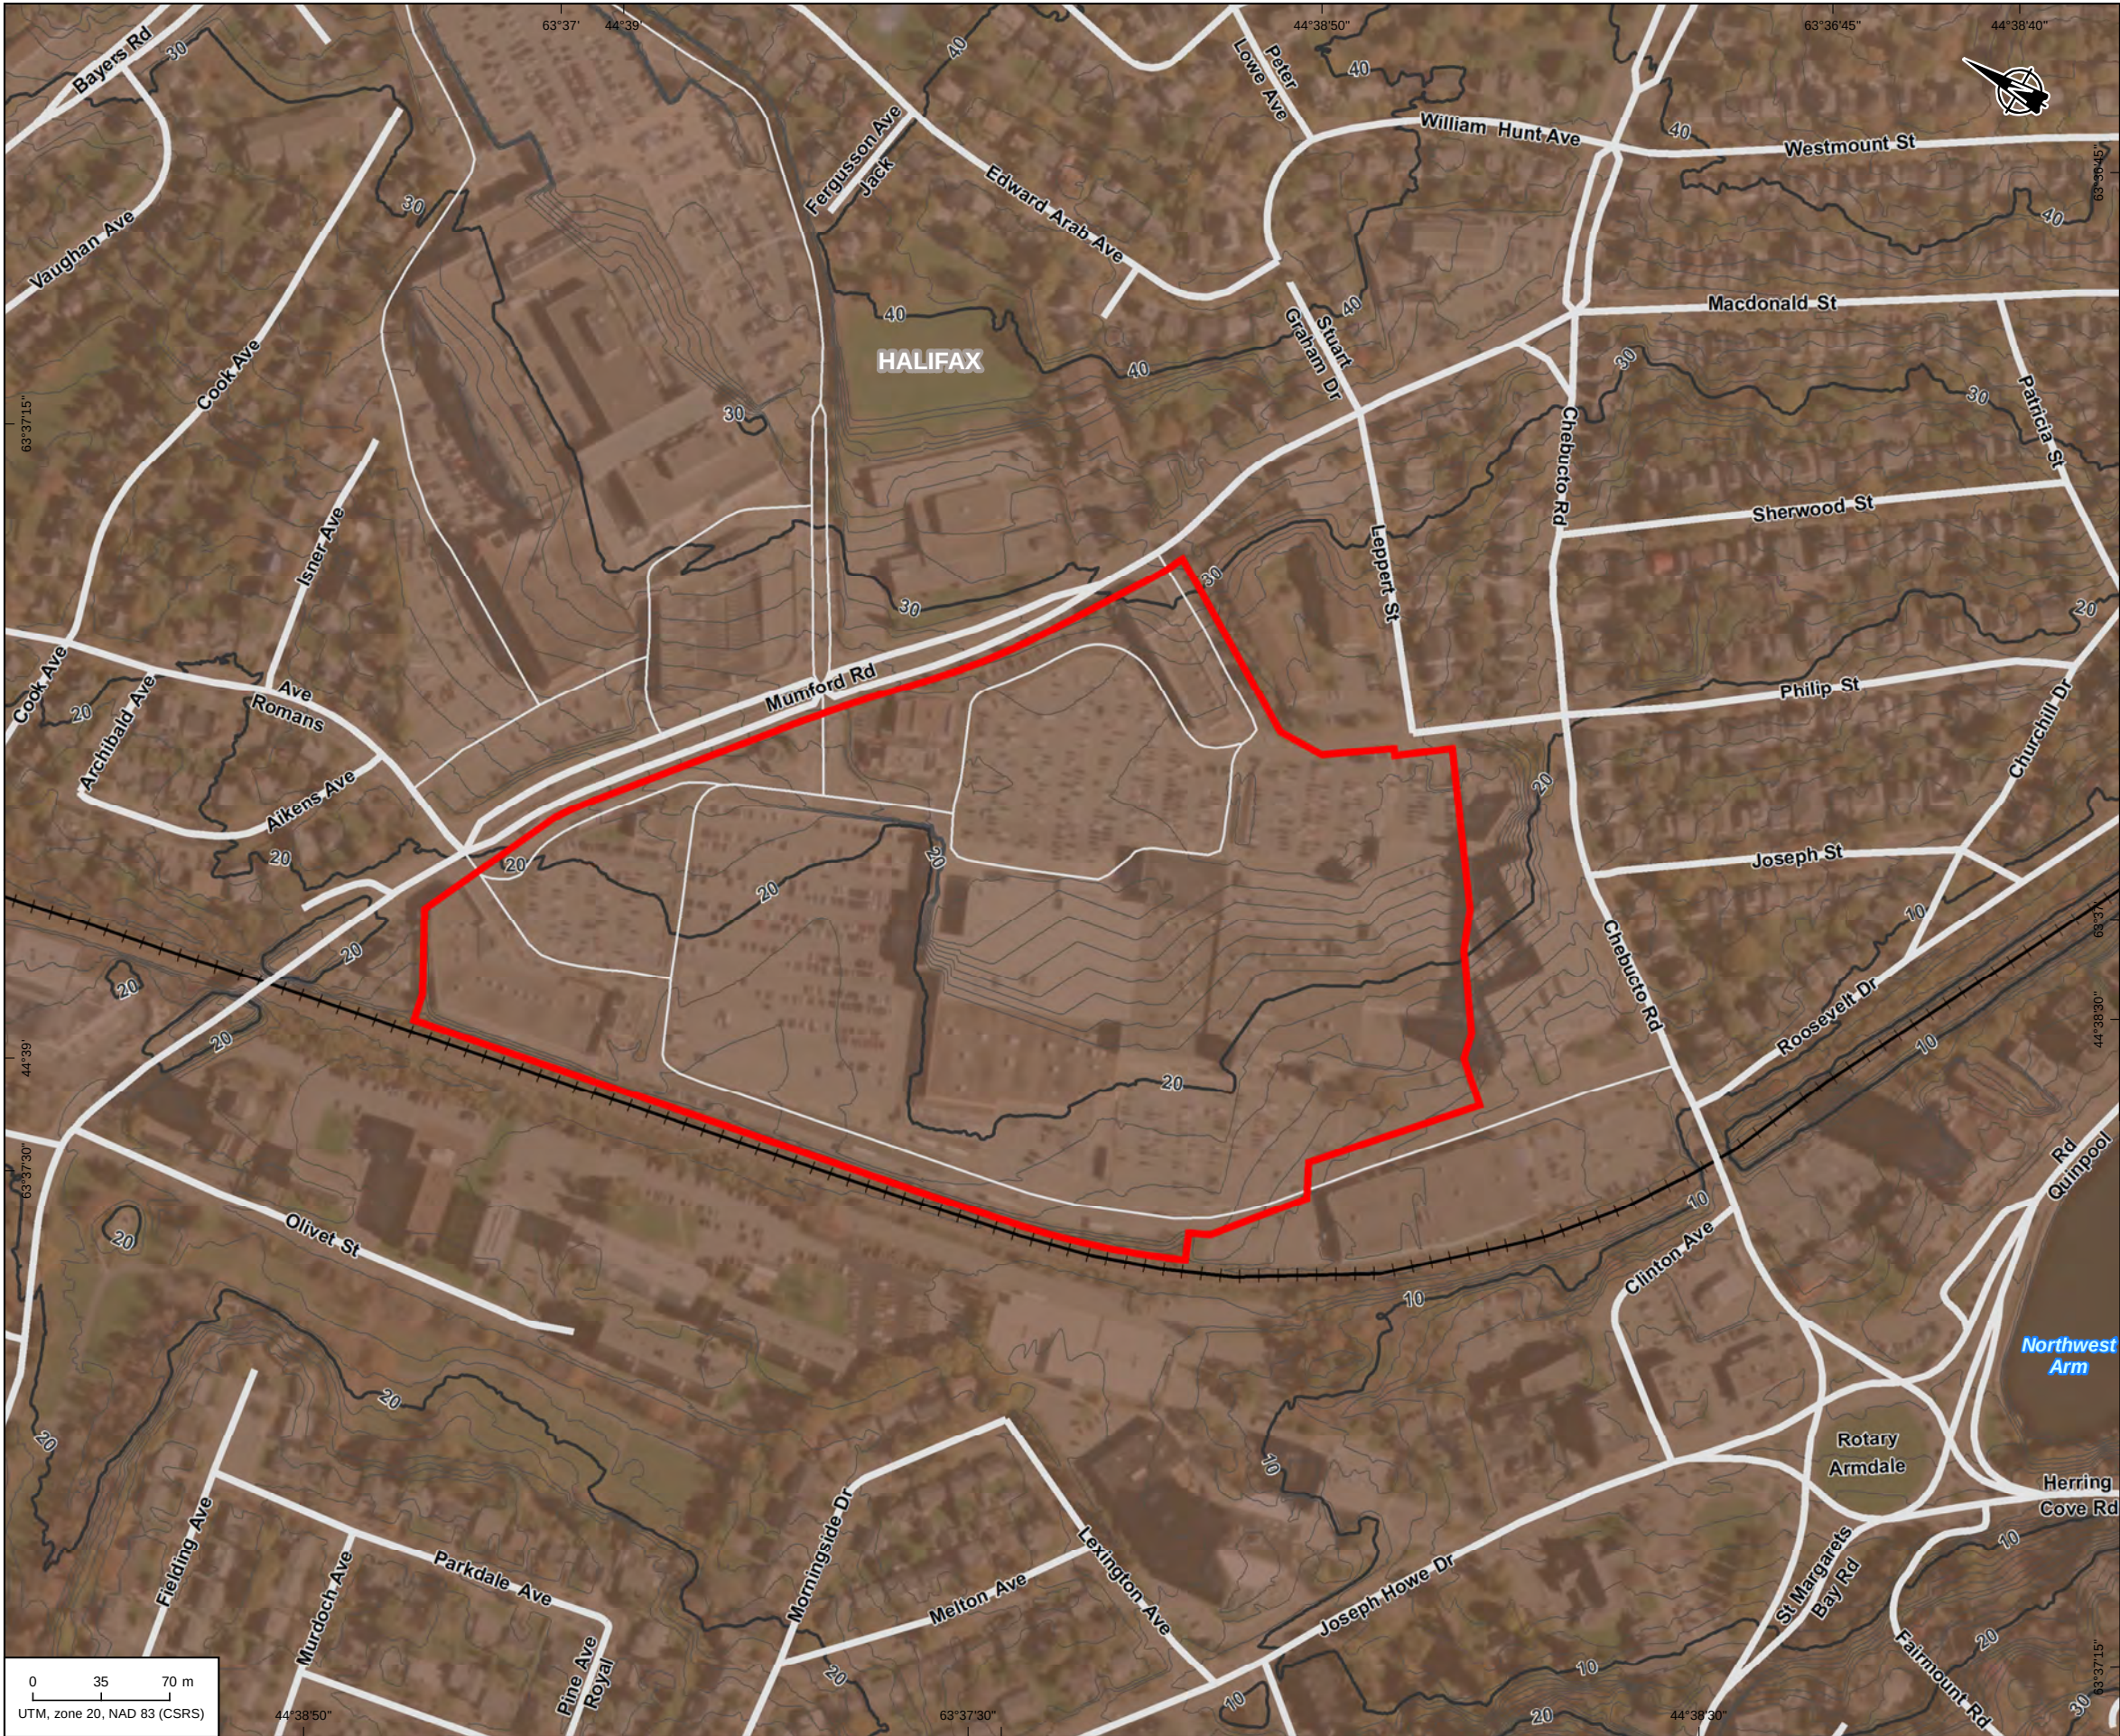
#### Figure 3 Bedrock

Geological mapping indicates that bedrock underlying the current area of interest is the Ordovician-aged Halifax Group of the Meguma Supergroup. In the study area, specifically the Cunard Formation is present. This unit is described as black to rust-brown slate with thin beds and lenses of minor black metasiltstone; medium-bedded, fine-grained, crosslaminated metasandstone. The Cunard Formation slates are prone to acid rock drainage and, as such, any disturbance of the bedrock must be in accordance with the *Nova Scotia Sulphide Bearing Material Disposal Regulations*.

Cunard Formation :  
black to rust-brown slate with thin beds and lenses of minor black metasilstone; medium-bedded, fine-grained, cross-laminated metasandstone; sulphide minerals common and prone to acid rock drainage

Bedrock geology is presented on Figure 3 and soil geology is presented in Figure 4.
